RECALL – Mustang Survival MRV170 Swiftwater Rescue Vest

Mustang Survival

Dec 20, 2018

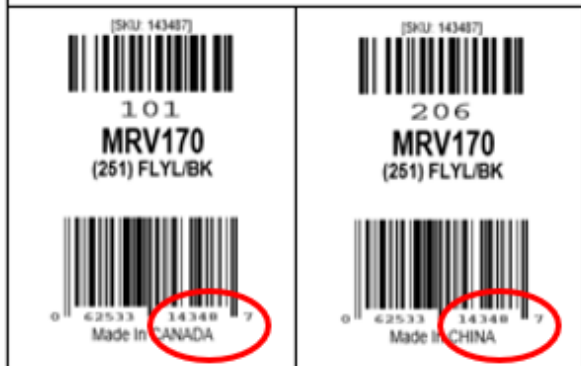
2015/2016 MRV170 PFD's

Affected Product; Needs Return

If the UPC is 062533 143487 (Made in Canada or Made in China), it has the old method of attachment and needs to be returned for modification. Proceed to the Return Instructions for sending back the product to Mustang Survival.

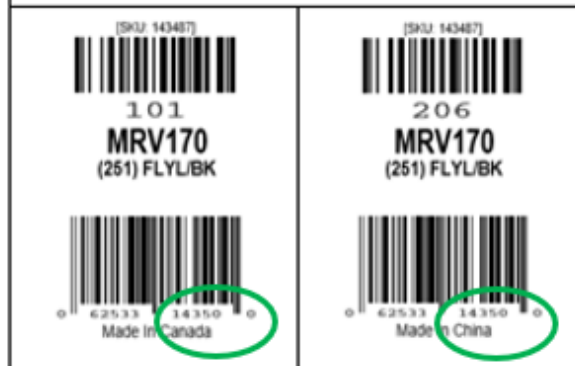
2018 MRV170 PFD's

Not Affected Product; New

If the UPC code is 062533 **143500**, it has the new method of attachment and is not affected by this recall advisory – do not return product.

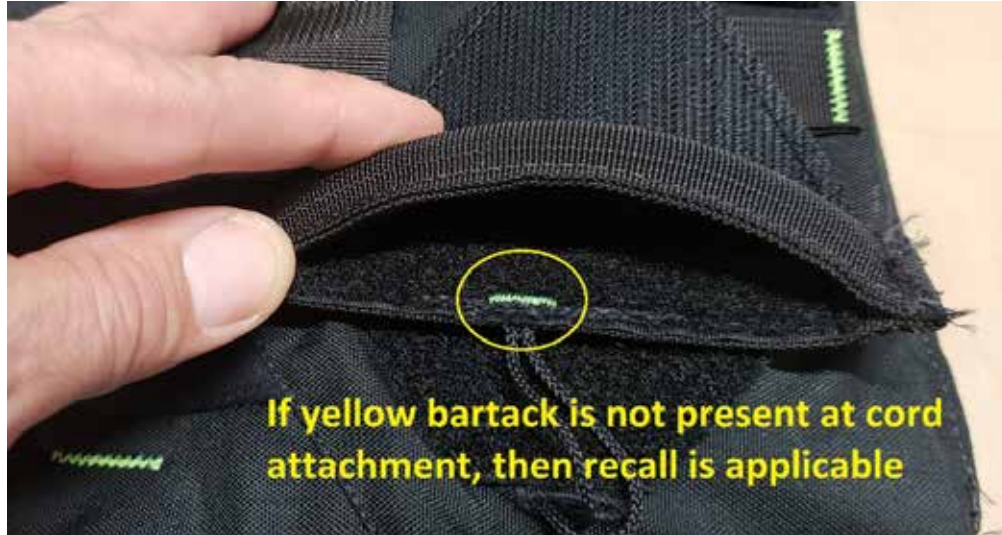
A. The strength of the inflator pull handle attachment is not consistently strong enough. If the inflator handle is pulled firmly, there is a chance that it may detach from the lanyard cords that trigger inflation of the vest bladder. This could prevent deployment of the 15lbs of supplemental buoyancy the bladder can provide in emergency situations.

2) PRODUCT IN USE: needs recall/repair if there is NO neon yellow sewing at inflator handle cord attachment point.

A. Please read the MRV170 advisory notice and immediately contact Mustang Survival's Customer Service at 1-800-526-0532 or via MRV170Advisory@mustangsurvival.com if you have any affected vest(s). Our Customer Service team will help facilitate their return to our Repairs facility where they will be quickly repaired, re-tested, and shipped back to you.
